# PISTON PIN BUSHING FAILURE

by Tony Saxton, Director of Tech Support, TTCF

## TEXTRON CESSNA MEL-79-01

## Continental Aerospace CSB07-01A

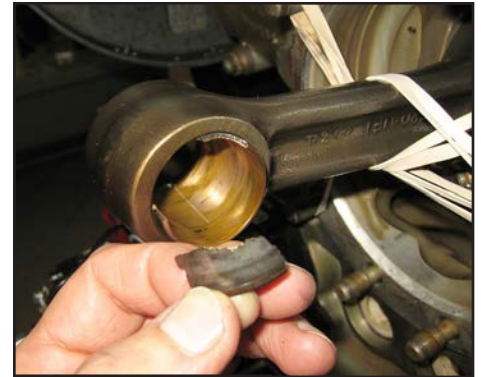
It has been determined that in some engines the bushing is moving laterally in the connecting rod and starting to extrude beyond one end of the rod. The extruded portion of the bushing becomes unsupported by the connecting rod and some edge pieces simply begin to break off.

*Above: Broken bushing on a 421C. Large pieces like this are usually found in the oil sump.*  
*Left: Picture from CSB07-01A.*

1) At any cylinder removal event, complete a detailed inspection of all visible areas for signs of piston pin bushing migration or edge chipping on the removed cylinder as well as any other observable rod ends.

2) During each and every scheduled oil change, strain the dumped oil through a fine mesh screen (Continental says 1000 microns .040” or less) and look for any pieces. Piston pin bushing pieces typically are rather large chunks and/or large pieces that are curved and resemble the lower fourth of a thumbnail. They are magnetic but a larger piece will show the bronze coating on one side.

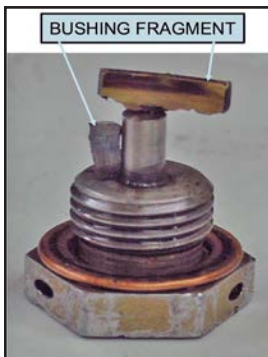
Another picture from CSB07-01A showing how a magnetic drain plug can capture a bushing fragment.

Another point that CSB07-01A makes is that there is a strong argument for installation of a magnetic drain plug in lieu of the standard plug. NOTE: The correct part number for the magnetic drain plug for all IO-470, IO-520, IO-550, TSIO-520, GTSIO-520 engines installed in the Twin Cessna is #636376.
